Manhole Inspection Summary

Manhole # S21KK_005MH

Insp Date: **5/31/07 11:09 AM**

Location Address: **1800 CLIFTON AVE**

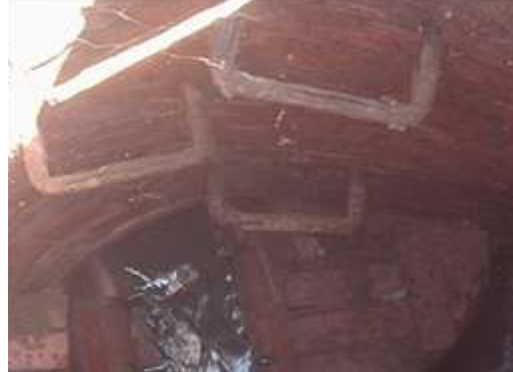
Defect 2

Count: **4** Missing: **1** ☒ **Corroded**

MISSING AND CORRODED STEPS

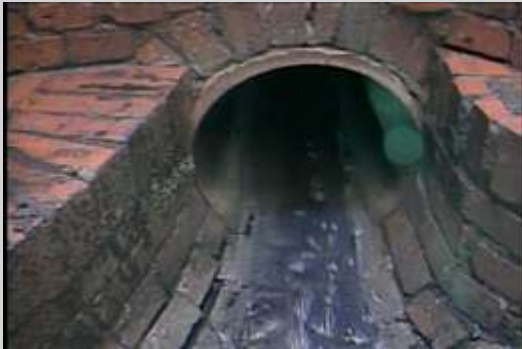
12 O'Clock Outflow

15 in. Circular Gravity Sewer
Pipe Out @ 12 O'Clock

Pipe Height: **14.4** (in.) Rod and Bar (Angled)
Pipe Material: **Clay** ☐ Pipe Lined
Invert Depth: **9.44** (ft.) Flow Characteristics: **Slow**
Deposits: ☒ None ☐ Mud ☐ Sludge ☐ Debris ☐ Grease
Silt Depth: (in.) Deposits Extent:
Infiltration: **None** Pipe Seal Cond: **Sound**

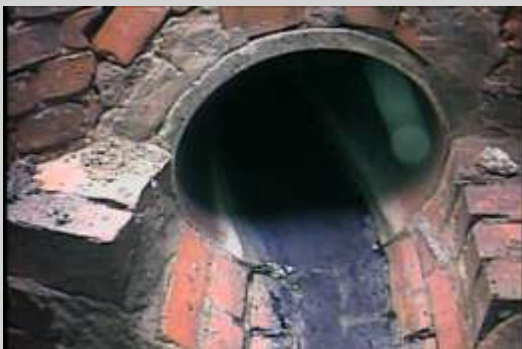
5 O'Clock Inflow

15 in. Circular Gravity Sewer
Pipe In @ 5 O'Clock

Pipe Height: **15.6** (in.) Rod and Bar (Angled)
Pipe Material: **Clay** ☐ Pipe Lined
Invert Depth: **8.74** (ft.) Flow Characteristics: **Slow**
Deposits: ☒ None ☐ Mud ☐ Sludge ☐ Debris ☐ Grease
Silt Depth: (in.) Deposits Extent:
Infiltration: **None** Pipe Seal Cond: **Sound**

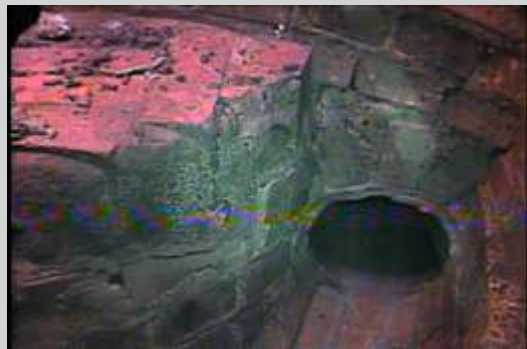
7 O'Clock Inflow

8 in. Circular Gravity Sewer

Pipe In @ 7 O'Clock

Pipe Height: **8.4** (in.) Rod and Bar (Angled)

Infiltration: **None** Pipe Seal Cond: **Sound**
